# Above the Flood: Elevating Your Floodprone House

FEMA 347/ May 2000

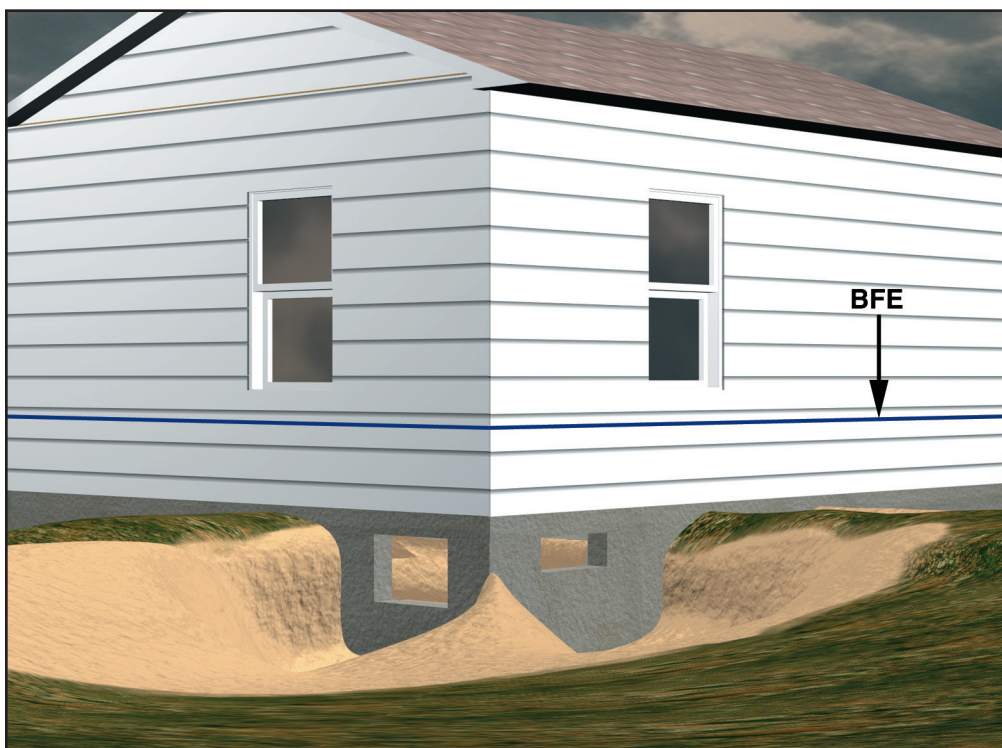
**Figure 17**  
Trenches and tunnels under the slab provide access for the jacks and I-beams that will lift the house.

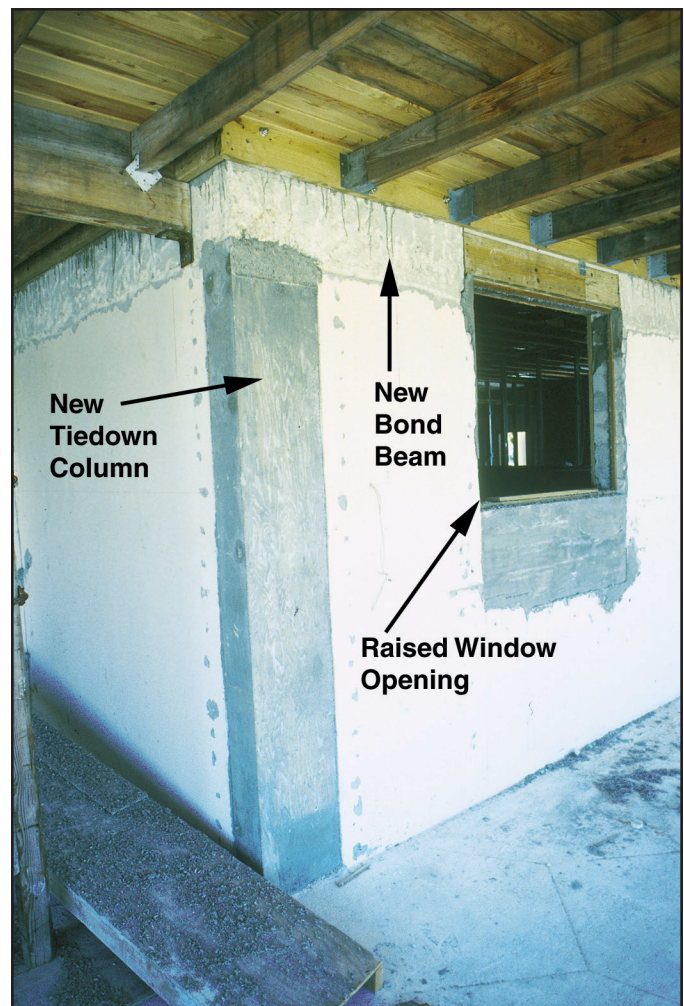
**Figure 41**

Note the new bond beam at the top of the extended wall, the new concrete tiedown column at the corner, and the raised window opening.

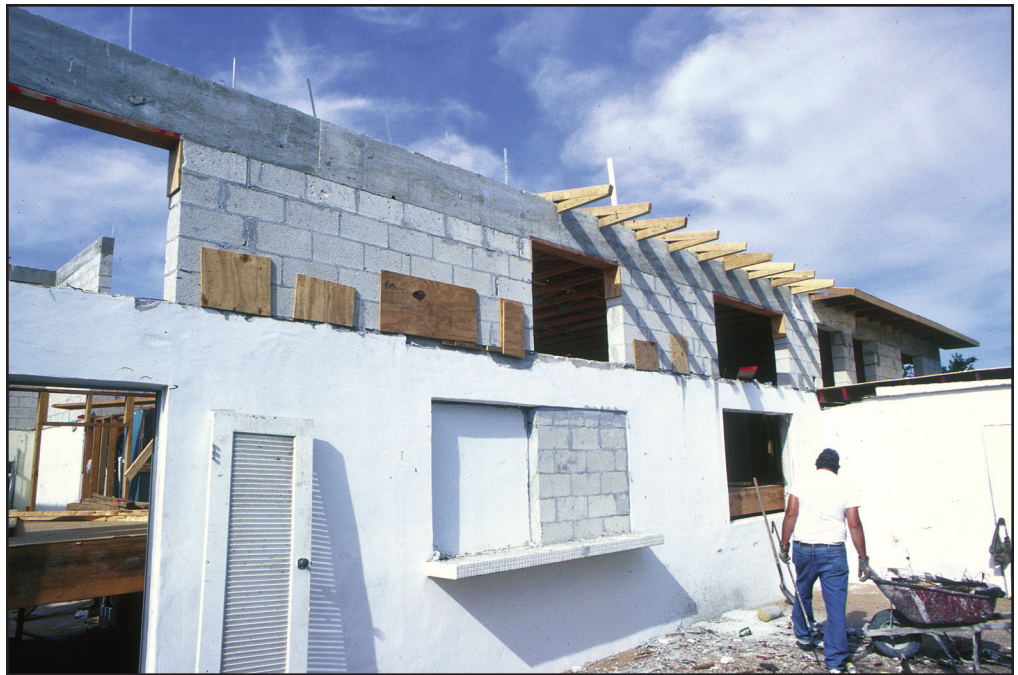
**Figure 67**  
The extended first-story walls.

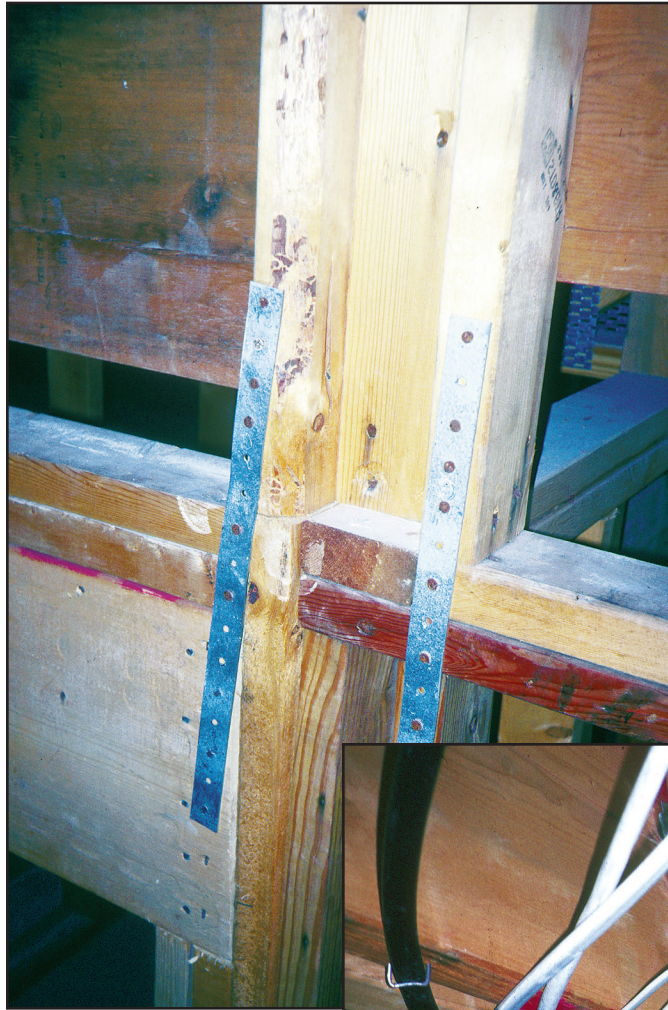
**Figure 70**

Metal hurricane straps are used to tie the structural members together and create a continuous load path from the roof to the foundation.
